**Subject: Preliminary Assessment
Shostak Metal Site, Kansas City, Missouri
CERCLIS ID: MON000706450
U.S. EPA Region 7 START, Contract No. EP-S7-13-06, Task Order No. 0104.005
Task Monitor: Jamie Bernard-Drakey, Site Assessment Manager**

PRELIMINARY ASSESSMENT

**SHOSTAK METAL SITE
KANSAS CITY, MISSOURI**

CERCLIS ID No. MON000706450

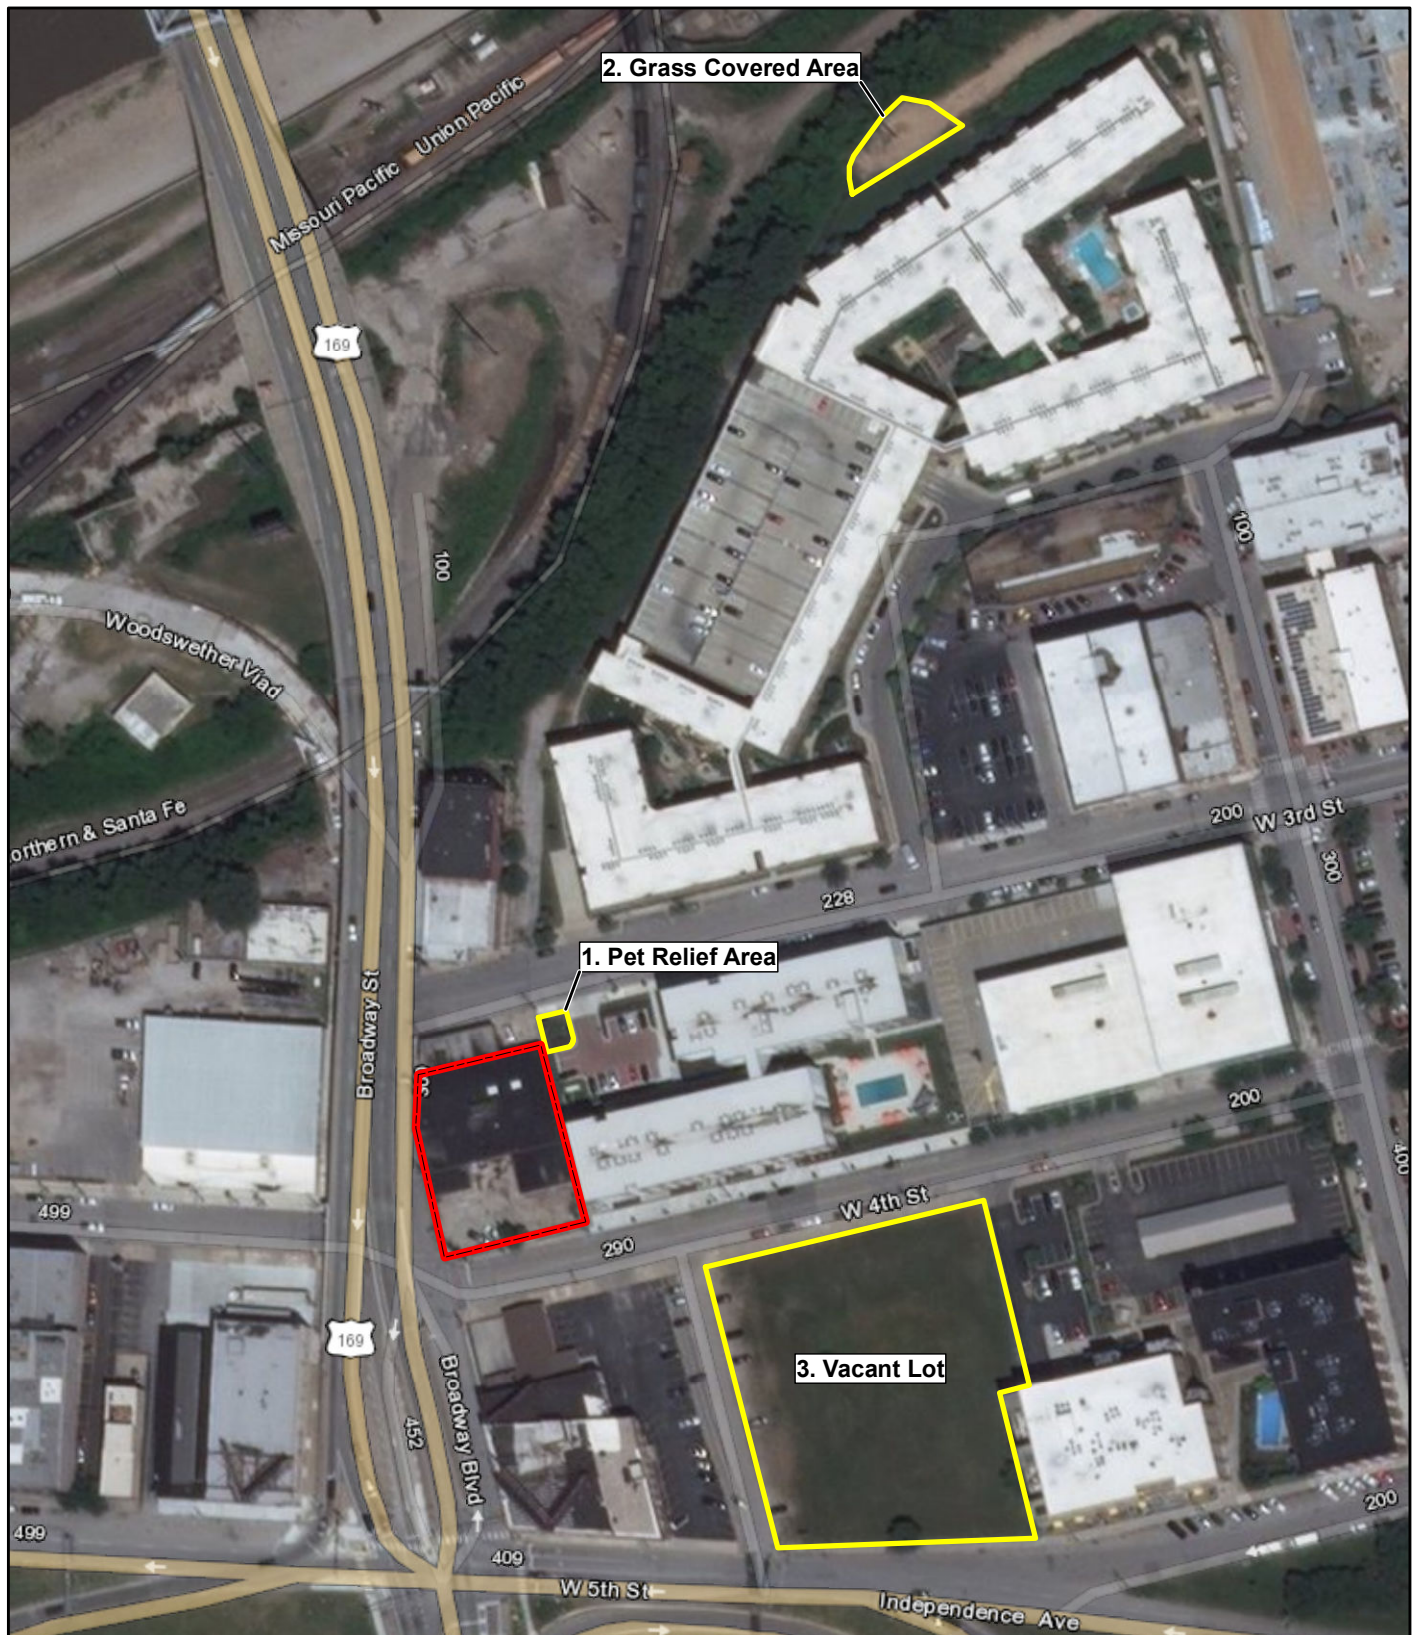
Figure 2
Site Layout Map

- Approximate site boundary
- Potential sampling area identified during initial site visit

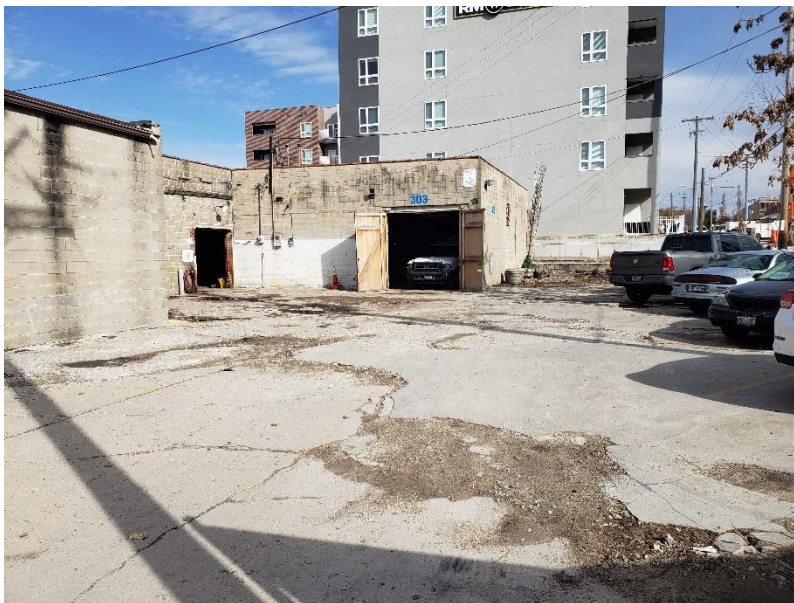
TETRA TECH PROJECT NO. 103X9025160104.005 Direction: Northeast	DESCRIPTION	This photograph shows the south side of the site building, the south and east facing garages, and parking area.	1
	CLIENT	U.S. Environmental Protection Agency Region 7	Date
	PHOTOGRAPHER	L. Holt	11/1/2018

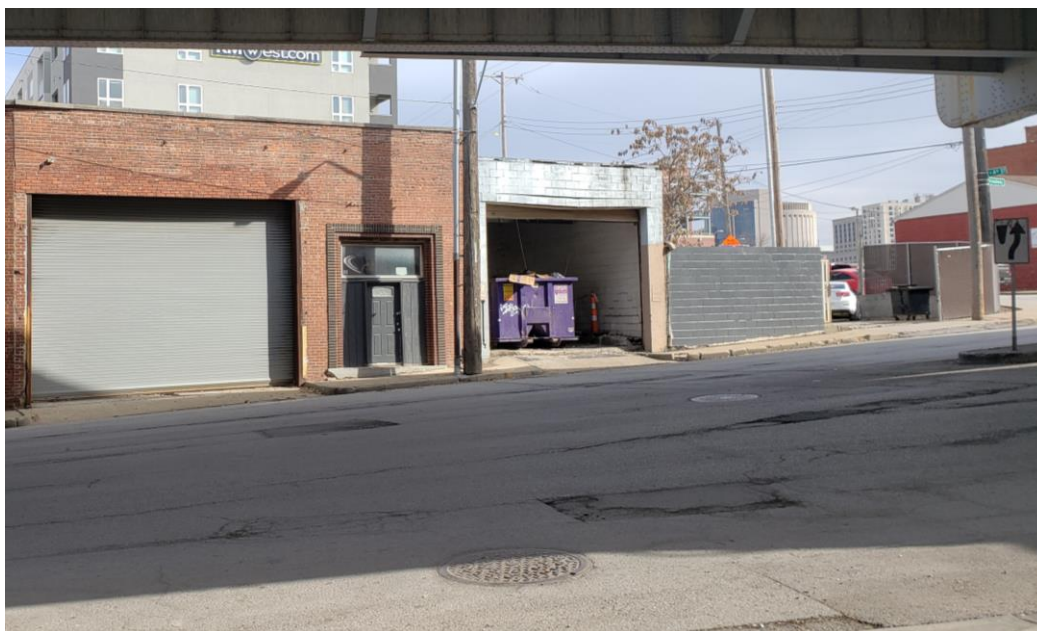
TETRA TECH PROJECT NO. 103X9025160104.005 Direction: Southeast	DESCRIPTION	This photograph shows the west facing garage entrances to the site property.	2
	CLIENT	U.S. Environmental Protection Agency Region 7	Date
	PHOTOGRAPHER	L. Holt	11/1/2018

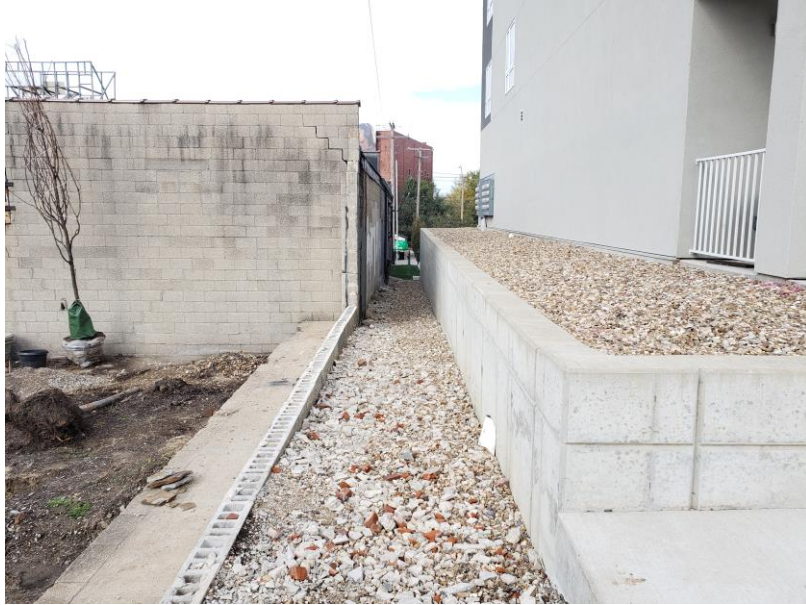
TETRA TECH PROJECT NO. 103X9025160104.005 Direction: North	DESCRIPTION	This photograph shows east side of the property and east adjoining apartment building.	3
	CLIENT	U.S. Environmental Protection Agency Region 7	Date
	PHOTOGRAPHER	L. Holt	11/1/2018

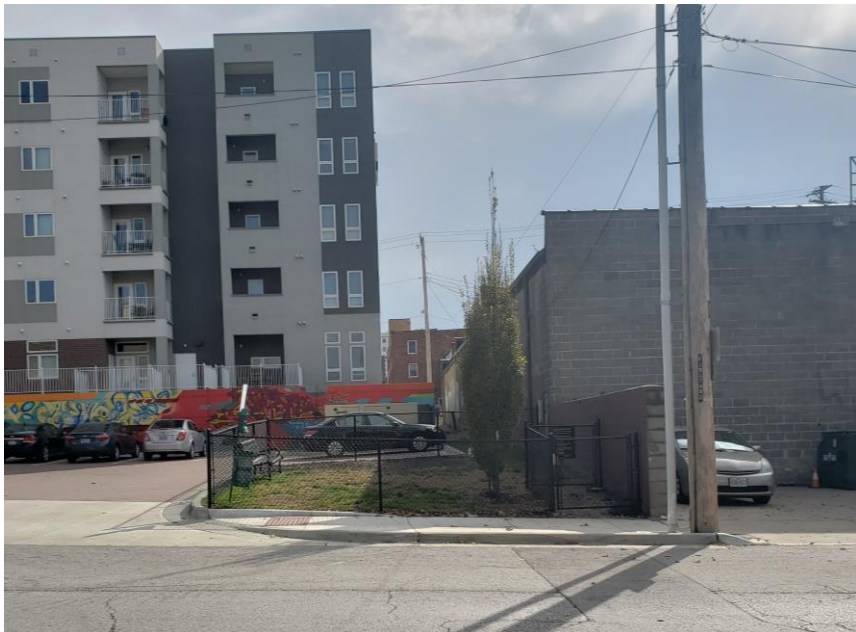
TETRA TECH PROJECT NO. 103X9025160104.005 Direction: South	DESCRIPTION	This photograph shows the pet relief area north of the site property.	4
	CLIENT	U.S. Environmental Protection Agency Region 7	Date
	PHOTOGRAPHER	L. Holt	11/1/2018

- The pet relief area north of the site was graded and sodded between September 2012 and September 2013 during installation of the paved parking lot for the east adjoining apartment structure.
- The grass-covered area between the Union Pacific railroad and Market Station apartments was covered with trees at least as late as September 2014 until removal of these sometime before May 2015.
- The vacant lot southeast of the site was occupied by a structure from as early as 1938. The structure was demolished, and the lot was cleared between 2001 and 2002. Additionally, shortly after the initial site visit, the Planned Industrial Expansion Authority of Kansas City approved plans for the River Market West II Apartment project on the lot. Construction is underway, and completion is expected in December 2019.

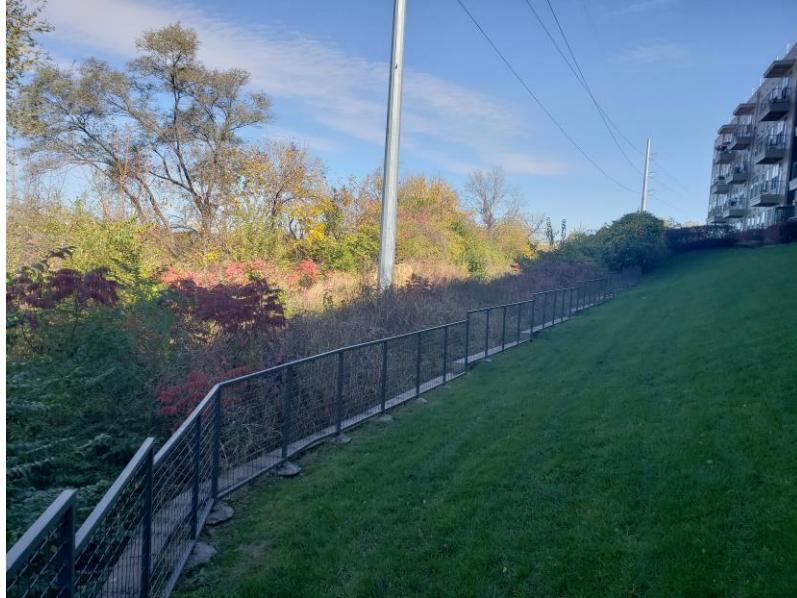
<p>TETRA TECH PROJECT NO. 103X9025160104.005</p> <p>Direction: Northeast</p>	DESCRIPTION	This photograph shows the grassy area north of the site behind the Market Station Apartments building and south of the Union Pacific Railroad.	5
	CLIENT	U.S. Environmental Protection Agency Region 7	Date
	PHOTOGRAPHER	L. Holt	11/1/2018

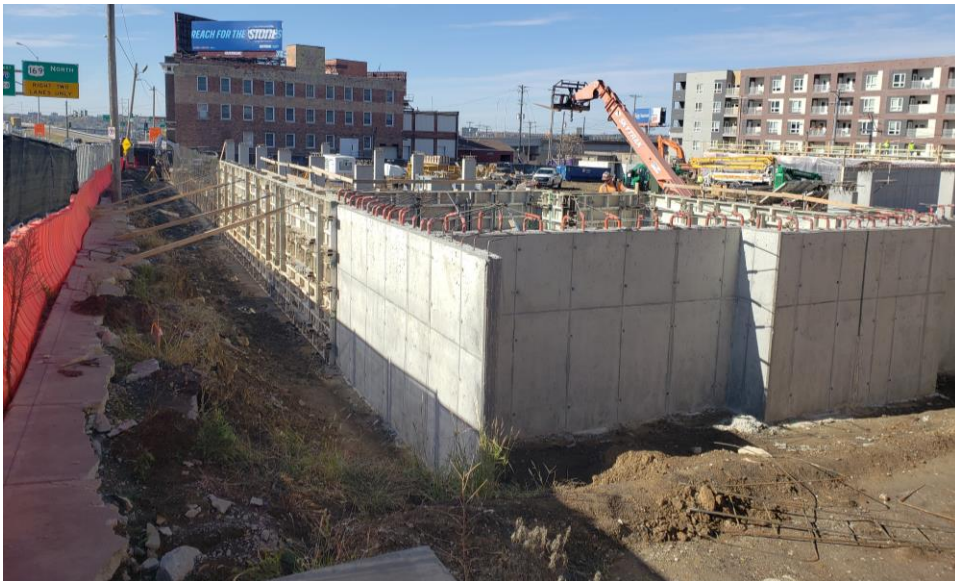
<p>TETRA TECH PROJECT NO. 103X9025160104.005</p> <p>Direction: Northwest</p>	DESCRIPTION	This photograph shows the current state of commercial development on the previously vacant lot southeast of the site.	6
	CLIENT	U.S. Environmental Protection Agency Region 7	Date
	PHOTOGRAPHER	L. Holt	11/1/2018
